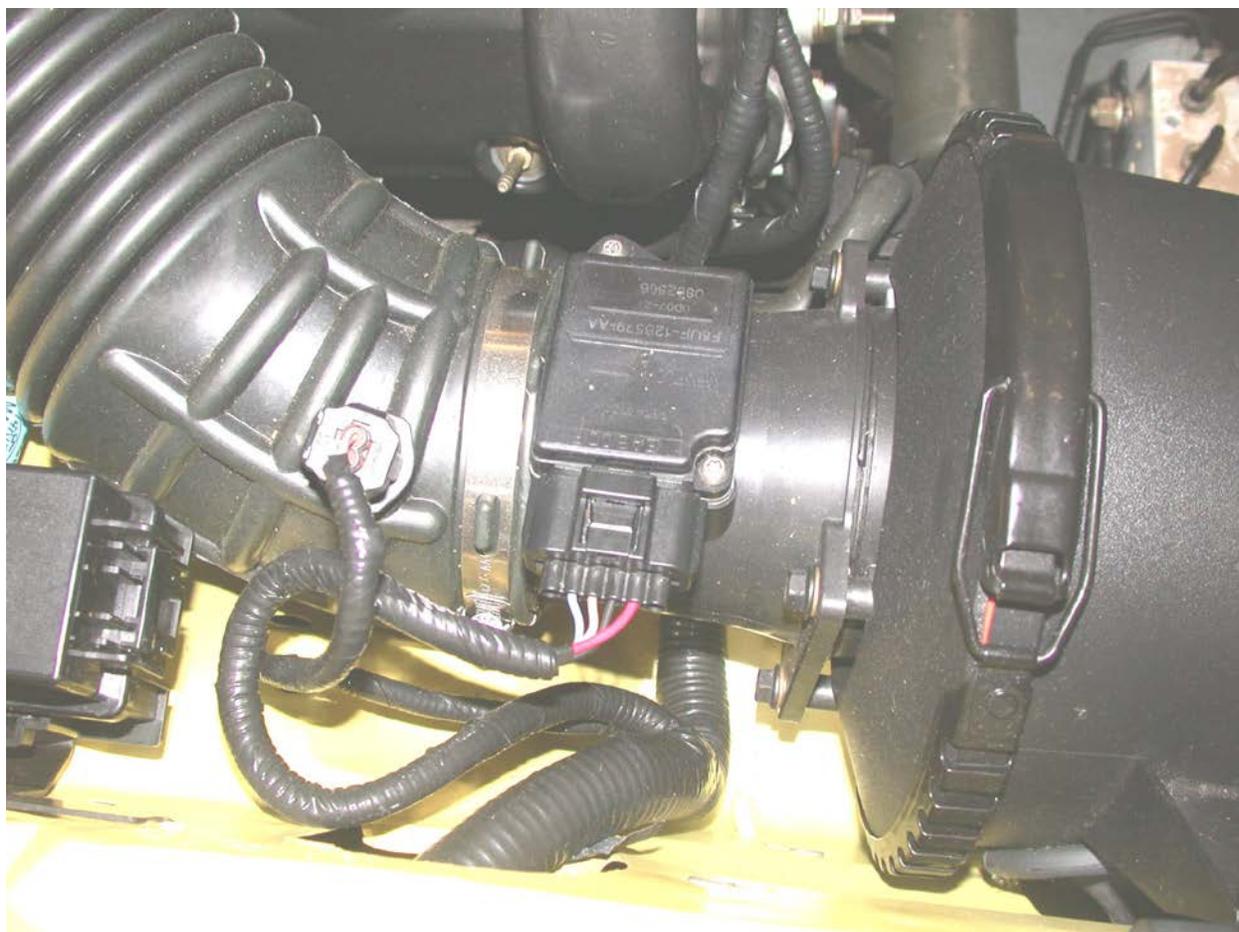
Halderman: The condition means that a major (called a high-authority) sensor is affecting the engine operation. There are two: the crankshaft position (CKP) sensor and the mass airflow (MAF) sensor. I have fixed several with this condition. I was lazy. It was easy to unplug the MAF sensor to see if the engine stalled, and it did not, so the MAF was replaced and the fault did not occur again. I know this is not the correct way to diagnose as I should have checked the output of the sensor over time using the movie mode of a scan tool or a scope. If you do unplug the MAF sensor, it will set a code so be prepared to clear it using a scan tool. The CKP could also be the cause and maybe more likely due to the high miles. The front bearing can wear on these 3800 engines causing the crankshaft reluctor rings to contact the sensor. The fix for this condition is to replace the main engine bearings. You can check this by checking for play at the crankshaft, most easily done through the right front wheel well.
