Wheels: An e-mail from Dave writes, “I own a 1992 Oldsmobile, Eighty-Eight Royale, which currently has a right front caliper which does not release properly. Initially I thought the caliper piston was mechanically seized. Unfortunately after replacing it, I discovered the problem persisted. I have reflashed the brake line via bleeding and performed the following tests: after cracking open the bleeder valve, the caliper releases. I then suspected the proportioning valve, however, when I disconnected the brake line from the master cylinder (the top rear fitting), the hydraulic pressure remained high enough, and the caliper does not quickly release the rotor. I did not disconnect the brake hose at the piping fitting to test (due to fear of rounding the nut on the brake line). At this point, I am unsure of what is a normal residual brake line pressure to confirm whether I have a restricted brake line/hose versus another caliper with a piston problem. Any suggestions would be greatly appreciated.”

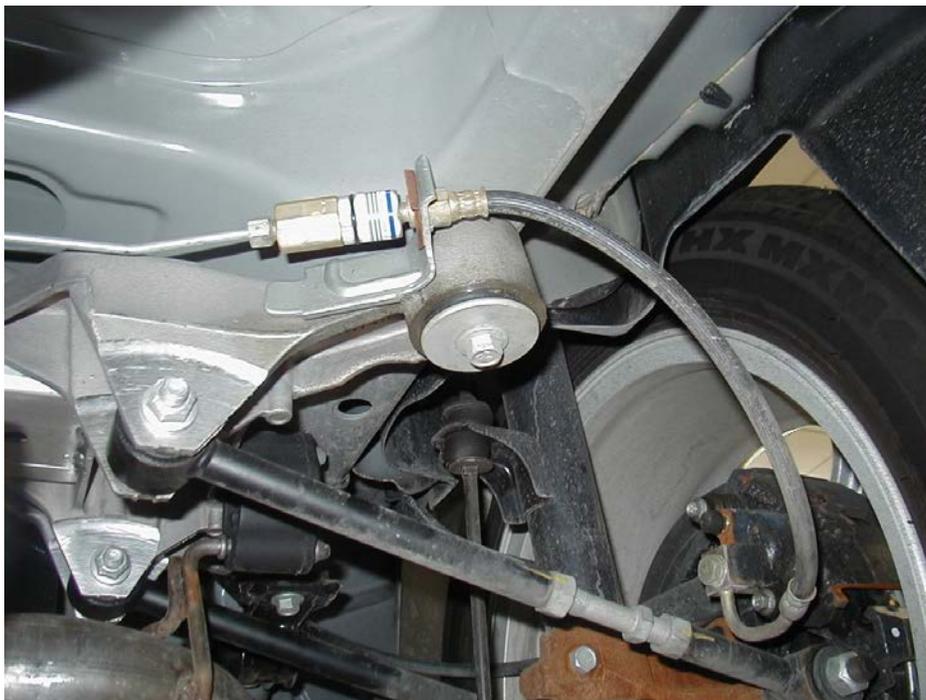
CAUTION: Never allow a caliper to hang from the rubber brake hose. The weight of the caliper can damage the inside of the rubber hose and could be the root cause of Dave’s problem.

Halderman: Check that the rubber brake hose has been installed correctly by observing the ribs on the outside of the hose. These ribs are manufactured into the hose to help service technicians notice if the hose has been twisted during service. It is not unusual for a service technician to twist a brake hose when the caliper assembly is reattached to the caliper mounting. All caliper slides and guide pins should be thoroughly cleaned and lightly lubricated with silicone brake grease. Do not use chassis or wheel-bearing grease because this can cause rubber brake seals and O-rings to swell causing the brakes to stick and not move freely as designed.
