FIGURE 29-1 The throttle pedal is connected to the accelerator pedal position (APP) sensor. The electronic throttle body includes a throttle position sensor to provide throttle angle feedback to the vehicle computer. Some systems use a Throttle Actuator Control (TAC) module to operate the throttle blade (plate).

Automotive Engine Performance, 3/e
By James D. Halderman

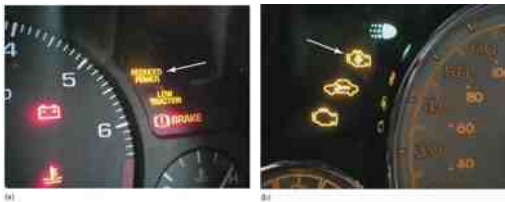
FIGURE 29-8 (a) A "reduced power" warning light indicates a fault with the electronic throttle control system on some General Motors vehicles. (b) A symbol showing an engine with an arrow pointing down is used on some General Motors vehicles to indicate a fault with the electronic throttle control system.

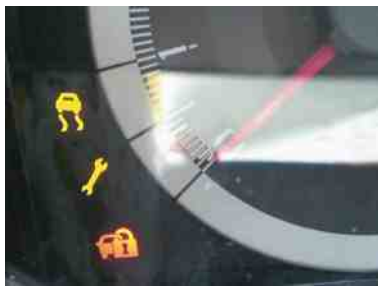
FIGURE 29-9 A wrench symbol warning lamp on a Ford vehicle. The symbol can also be green.

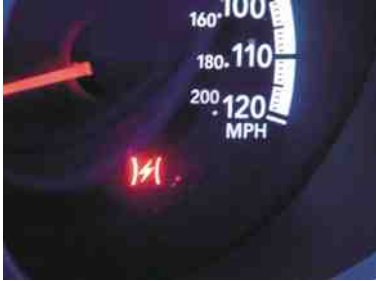
FIGURE 29-10 A symbol used on a Chrysler vehicle indicating a fault with the electronic throttle control.

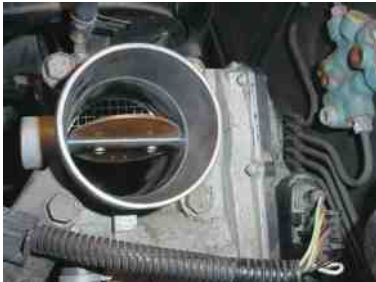
FIGURE 29-11 The throttle plate stayed where it was moved, which indicates that there is a problem with the electronic throttle body control assembly.

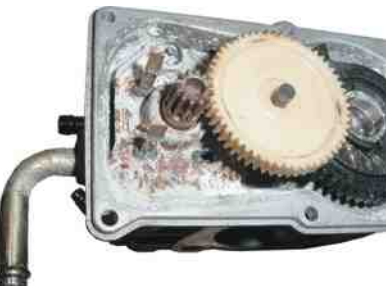
FIGURE 29-12 A corroded electronic throttle control assembly shown with the cover removed.

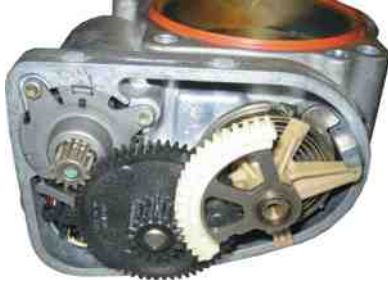
FIGURE 29-13 Notice the small motor gear on the left drives a larger plastic gear (black), which then drives the small gear in mesh with the section of a gear attached to the throttle plate. This results in a huge torque increase from the small motor and helps explain why it could be dangerous to insert a finger into the throttle body assembly.
