84 EXHAUST GAS RECIRCULATION SYSTEMS

ALWAYS LEARNING Automotive Technology, Fifth Edition James Halderman PEARSON

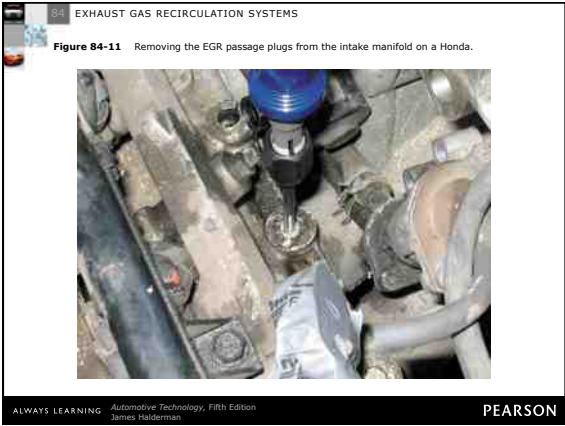
SEE FIGURE 84-11.

The EGR passages on many intake manifolds become clogged with carbon, which reduces the flow of exhaust and the amount of exhaust gases in the cylinders. This reduction can cause spark knock (detonation) and increased emissions of oxides of nitrogen (NO<sub>x</sub>) (especially important in areas with enhanced exhaust emissions testing).

To quickly and easily remove carbon from exhaust passages, cut an approximately 1-foot (30-cm) length from stranded wire, such as garage door guide wire or an old speedometer cable. Flame the end and place the end of the wire into the passage. Set your drill on reverse and turn it on, and the wire will pull its way through the passage, cleaning the carbon as it goes, just like a snake in a drainpipe. Some vehicles, such as Hondas, require that plugs be drilled out to gain access to the EGR passages.
