Automatic Transmissions and Transaxles
Seventh Edition
James D. Halderman

Chapter 14
In-Vehicle Transmission/
Transaxle Service

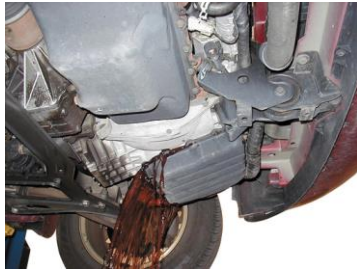
FIGURE 14-1 Draining the fluid from an automatic transaxle by allowing the fluid to flow into a container after most of the retaining bolts have been removed.

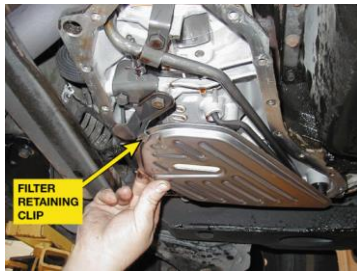
FIGURE 14-2 Always check that the filter is secured by a clip or other fastener to keep it from dropping out of its position.

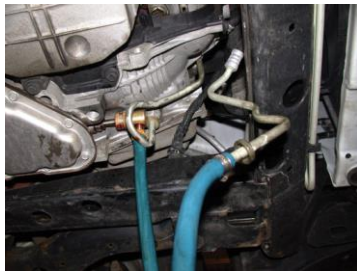
FIGURE 14-4 The lines from the fluid exchange machine can often be connected to the cooling lines from underneath the vehicle as on this front-wheel-drive General Motors vehicle.

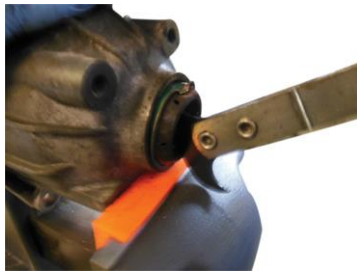
FIGURE 14-5 This seal is being removed using a seal puller.

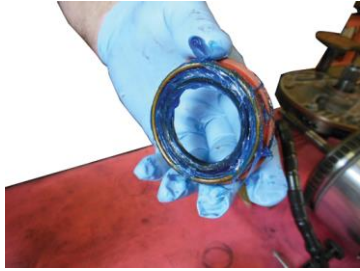
FIGURE 14-6 The lip of the seal around the garter spring is packed with assembly lube to help keep the spring from falling out when it is driven into the transmission housing.

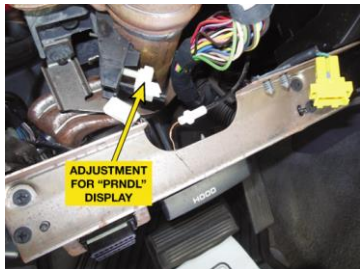
FIGURE 14-8 The position for the pointer (“PRNDL” display) on this Dodge truck is adjustable.

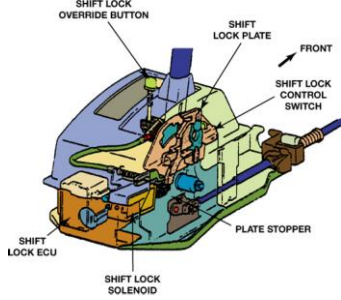
FIGURE 14-10 This shift lock mechanism includes a solenoid that can mechanically hold the shift lock plate. Note the shift lock override button that can be used to release the shift lock.
