40 USED VEHICLE AND PRE-DELIVERY INSPECTIONS

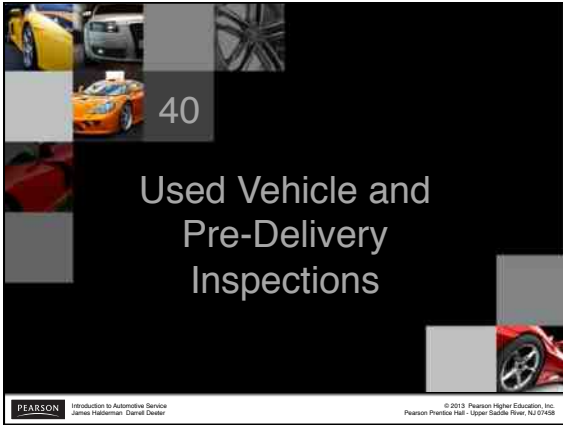
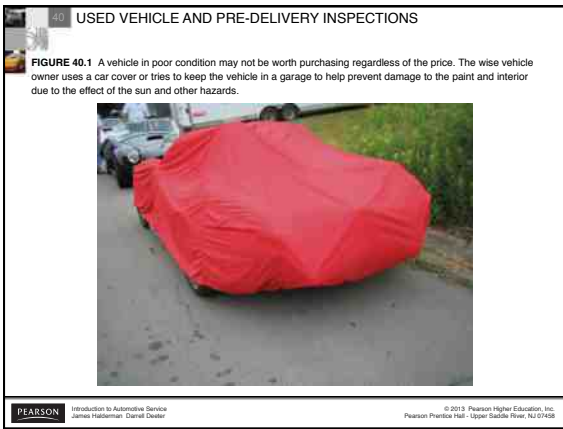
(a) (b)

FIGURE 40.3 (a) The left side of a lift gate on an SUV shows a wide gap. (b) The right side of the same lift gate on the passenger side shows a very small gap. This shows that this vehicle may have been in an accident and not properly repaired.
