Wheels: Curt of Xenia writes that the temperature indicator (gauge on the dash) reads hotter than normal after the water pump and timing belt were replaced on his 1986 Toyota Camry. Curt states that the engine runs okay, but is concerned that it may overheat with the hot summer months approaching. Do you have any suggestions?

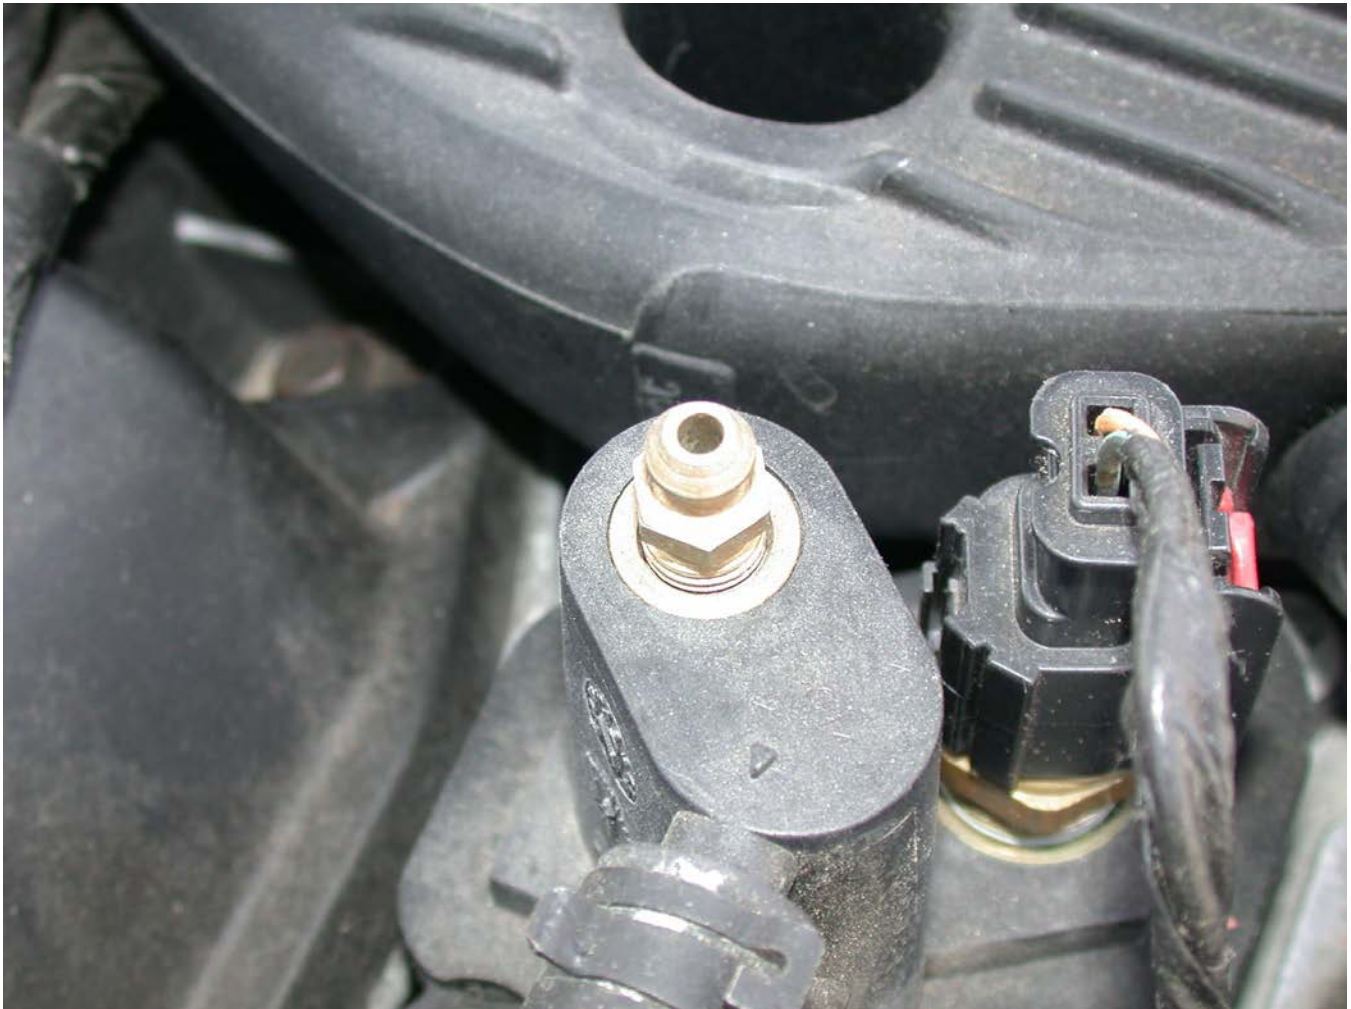
Halderman: Any problem with the cooling system should be corrected as soon as possible to avoid future problems. Your letter indicated that the temperature gauge read in the normal range until the timing belt and water pump were replaced. This seems to indicate to me that there may be an air pocket in the cooling system. This is a common occurrence and is caused by air getting into the upper sections of the cooling system and then being trapped when fresh coolant is installed after the water pump replacement. Many vehicles are equipped with an air bleeder valve that allows the air to escape as the cooling system is being filled. It is often necessary to raise the front of the vehicle so that the trapped air can rise through the system and escape. Ask the service technician to bleed the system again. It is often necessary to bleed the system several times before all of the air is expelled. I have had good success by loosening the radiator cap when the engine is cold, then driving the vehicle until it reaches operating temperature. This procedure often allows the trapped air to escape around the radiator cap. After driving, I stop the engine and check the coolant level and add coolant (antifreeze and water mixed 50/50) and then tighten the radiator cap and again drive the vehicle checking for proper operation of the temperature gauge and heater.
