Wheels: Fritz via e-mail writes that his 1989 Chevrolet Astro van will often stall when slowing to a stop. This only happens when he has driven the vehicle for about 20 miles. He was told this could be the torque converter clutch (TCC). Fritz wants to know how the TCC is activated and does this mean he needs a new computer?

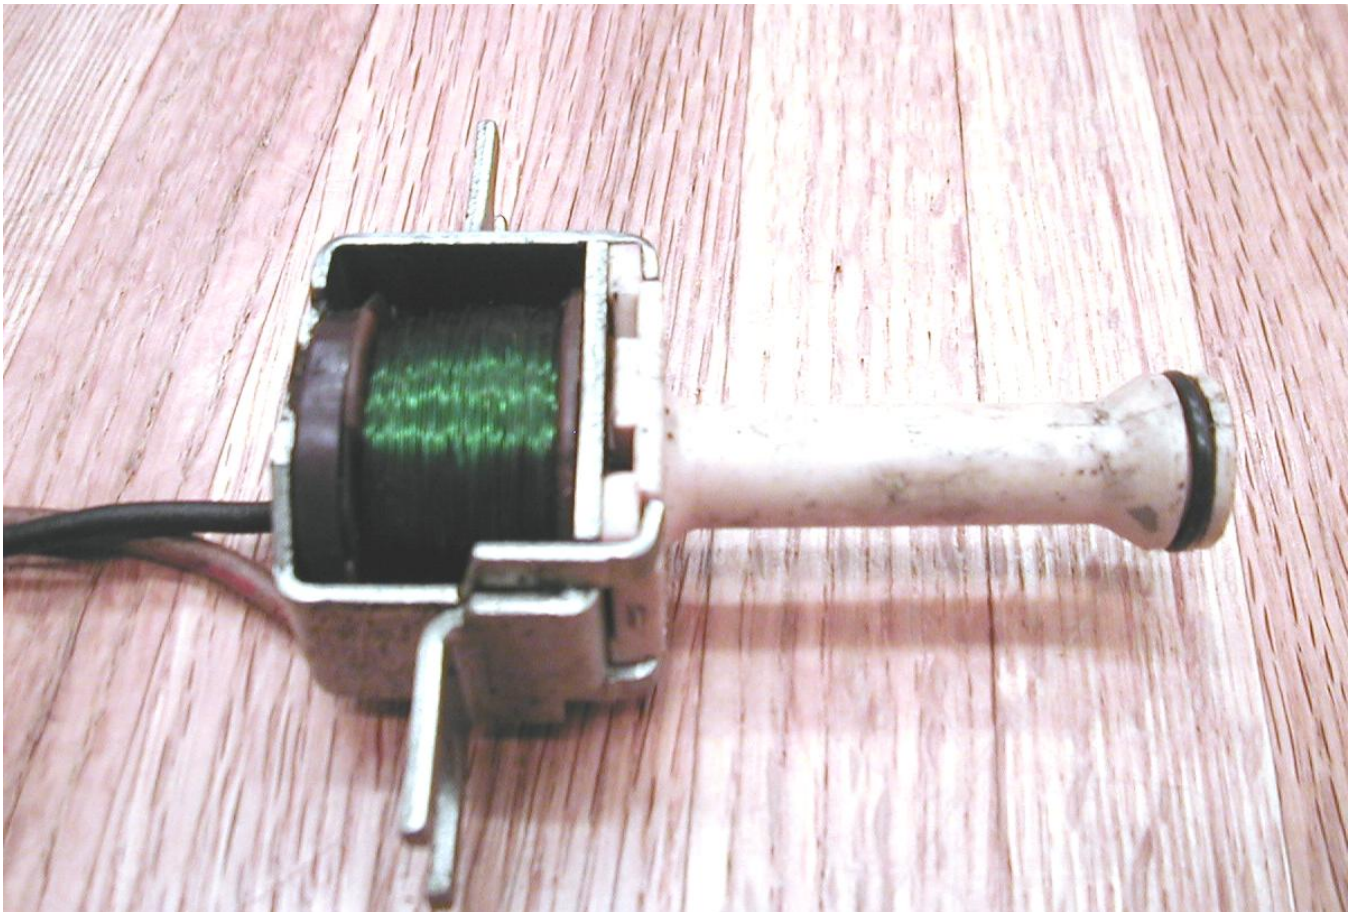
Halderman: The TCC is activated by the computer based on many sensors. It could be sticking in the applied position causing the van to stall after you drive it. This fault is a common pattern failure for this transmission and a new computer is not necessary. Try unplugging the connector on the driver's side (three wire connector) to see if this solves the problem. If it does, have the TCC solenoid replaced. To prevent possible transmission problems, do not drive with the connector disconnected for very long. Just test drive the van to check if the problem is solved and do not tow anything or drive in hilly areas with the connector disconnected because it could cause the transmission to overheat. If the problem still exists with the connector unplugged, then the problem is due to a fault inside the transmission itself. Consult a transmission expert for repairs. A common cause could be a fault in the valve body. This assembly can be replaced without having to remove the transmission from the vehicle.
