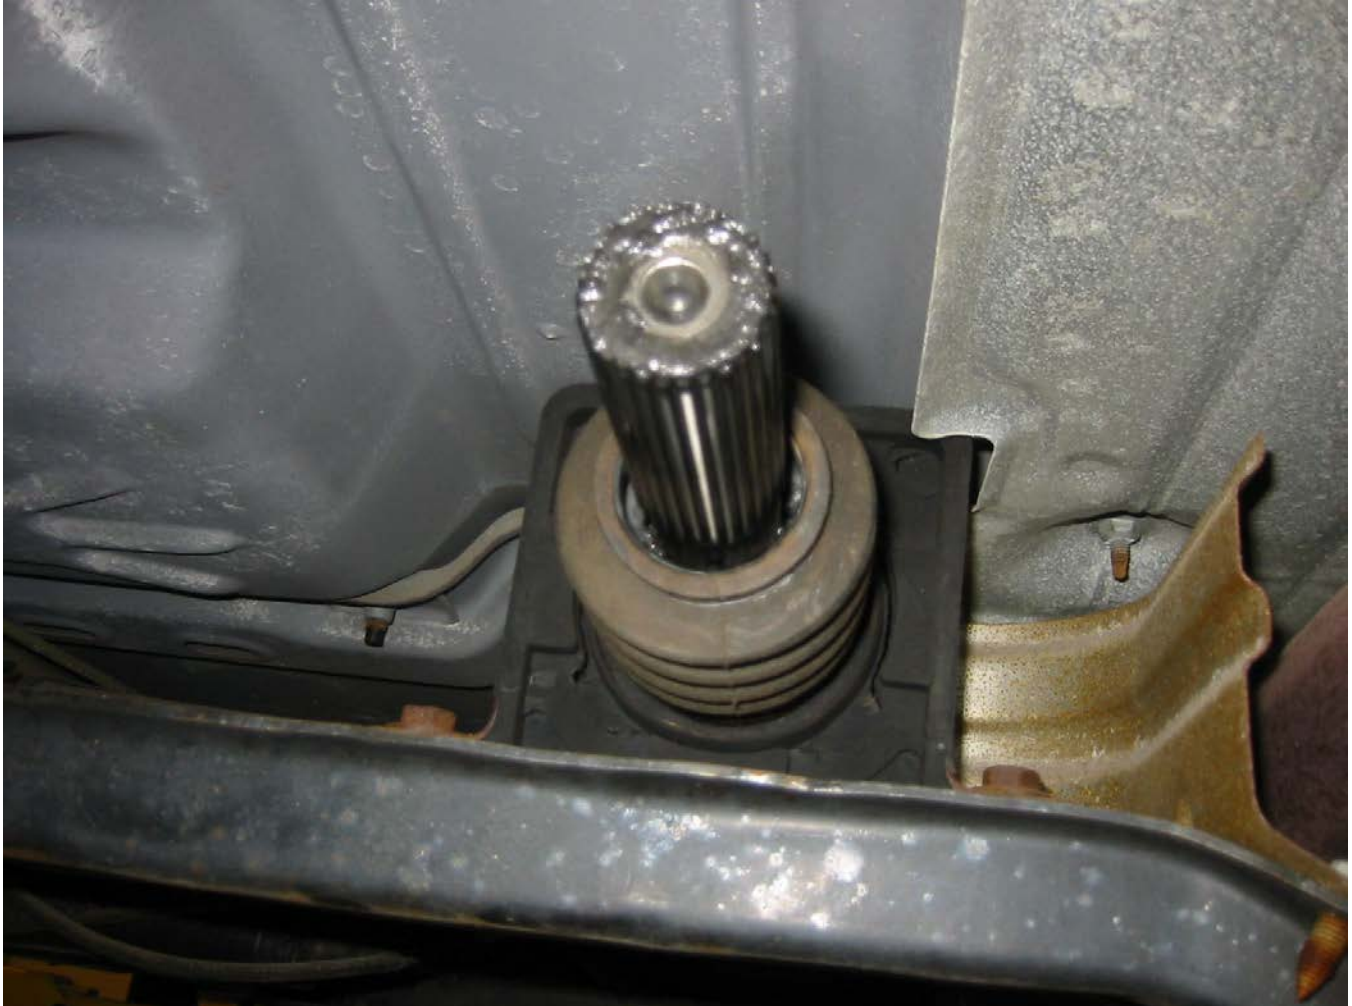
Halderman: This is a common problem and it is usually due to lack of grease in the splines of the driveshaft. The driveshaft has to be removed and then a high-temperature grease applied to the splines and reinstalled.
