**Wheels:** An e-mail from Don says, “You were kind enough to help my son out a couple of weeks ago with a question regarding the cause of a collapsing radiator hose. He replaced the radiator cap as you suggested and has had no problems. We should all be so lucky to get by with a \$4.00 fix.

I have a problem with my 2003 GMC Envoy SLT. It has approximately 32,000 miles. At about 30,000 miles, the SUV developed what I would call a rocking motion that occurs approximately between 30 and 50 mph. Above that, there might be a small vibration in the steering wheel, but not really noticeable. It seems to occur both on acceleration and deceleration. However, under harder acceleration, the motion does not occur. I thought the wheels might be out of balance, so I had them balanced and rotated as part of my 30,000 mile oil change with no change in behavior. My wife had a similar problem with her Jag X-type and it turned out to be a bent rim. The SLT has aluminum wheels. I was wondering whether the behavior I described indicates a similar condition with the Envoy? If so, how is it detected and repaired?”

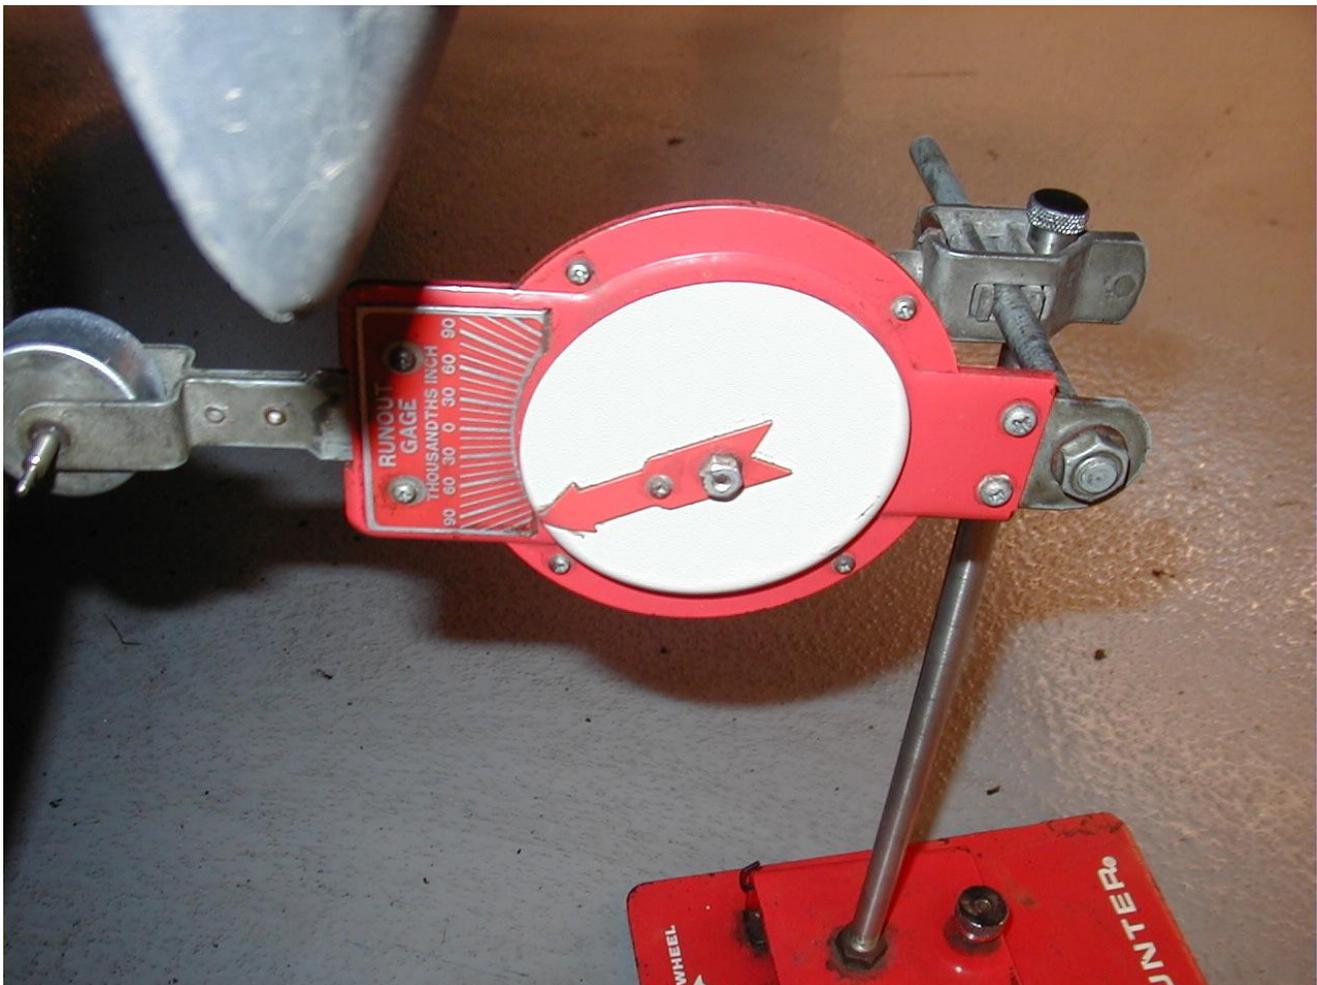
The normal procedure used to locate this type of fault is for the service technician to hoist the vehicle about 2 inches off the ground and use a runout gauge to measure both the radial (out-of-round) and lateral (side-to-side) movement of the wheel, tire, and hub. Normal specification for runout is less than 0.060 inch or about the thickness of a nickel. If excessive runout is found, then either the wheel or the tire or both would need to be replaced to solve the problem.

- A defective tire where the steel belt around the circumference of the tire has shifted causing the side-to-side motion.
- A bent wheel usually caused by hitting a curb or other similar situation.
- In severe cases, the bearing hub could be bent.
