**Wheels:** An e-mail from Tim says, “I have a 2001 Pontiac Grand Am. The rear window defogger has two metal tabs attached to the window - one on the passenger side and one on the driver’s side. One of them has come detached. The dealer says that I have to replace the window. What? They can put a man on the moon.... Well, you know the rest. Is there a simpler solution to my problem?”

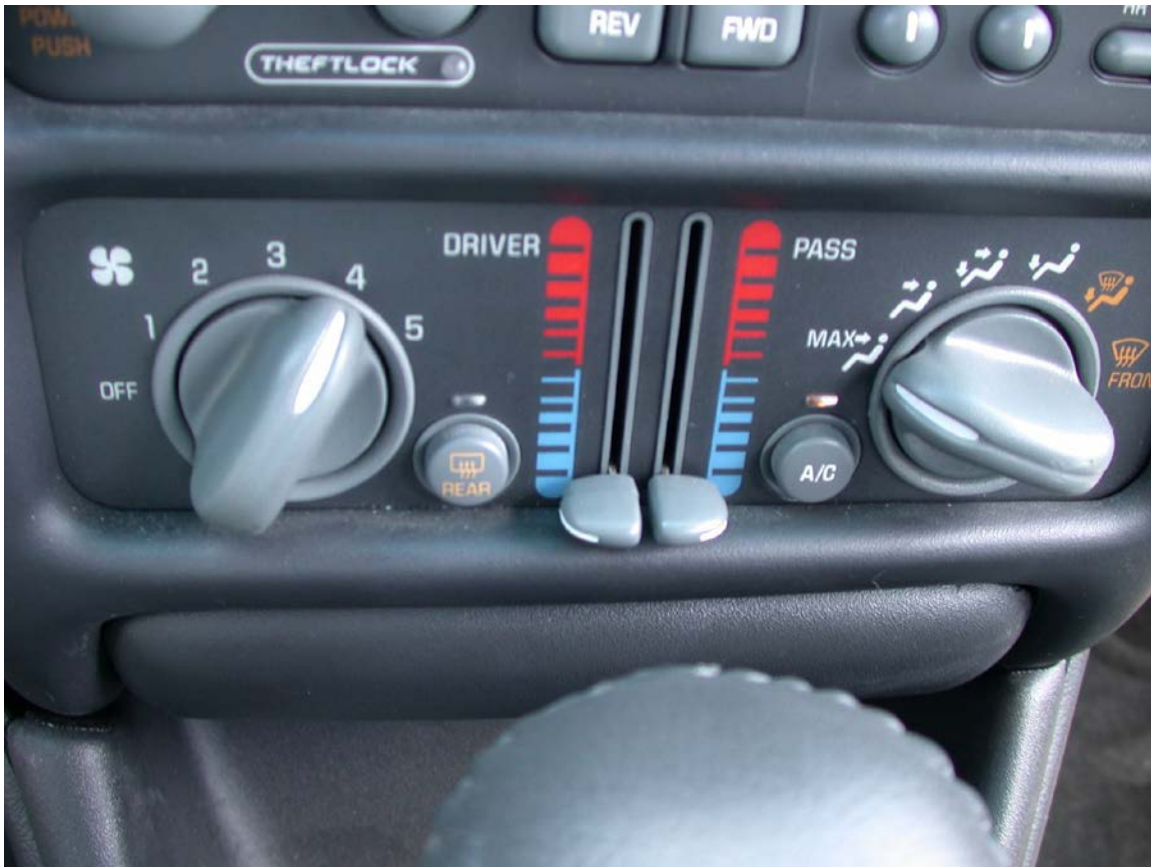
**Halderman:** The “correct answer” is yes, the rear window needs to be replaced. The factory does not have a good solution to fix the rear window connection. However, you may be able to locate some electrically conductive epoxy cement and try reattaching it to the rear window. However, due to the current flow through this connection, this repair is seldom long lasting.
