Wheels: A letter from John of Fairborn says, “I have a 1995 GMC van with a 4.3 liter V-6 engine. It has 141,424 miles. I was getting 13 mph on the highway and had the engine overhauled last summer. My gas mileage is now at 11 mph on the highway. I had the engine on the analyzer and the computer thing by the steering column under the dash. No codes/errors were found. The van has been to three different repair places. All three places suggested replacing parts at random. Can you help?”

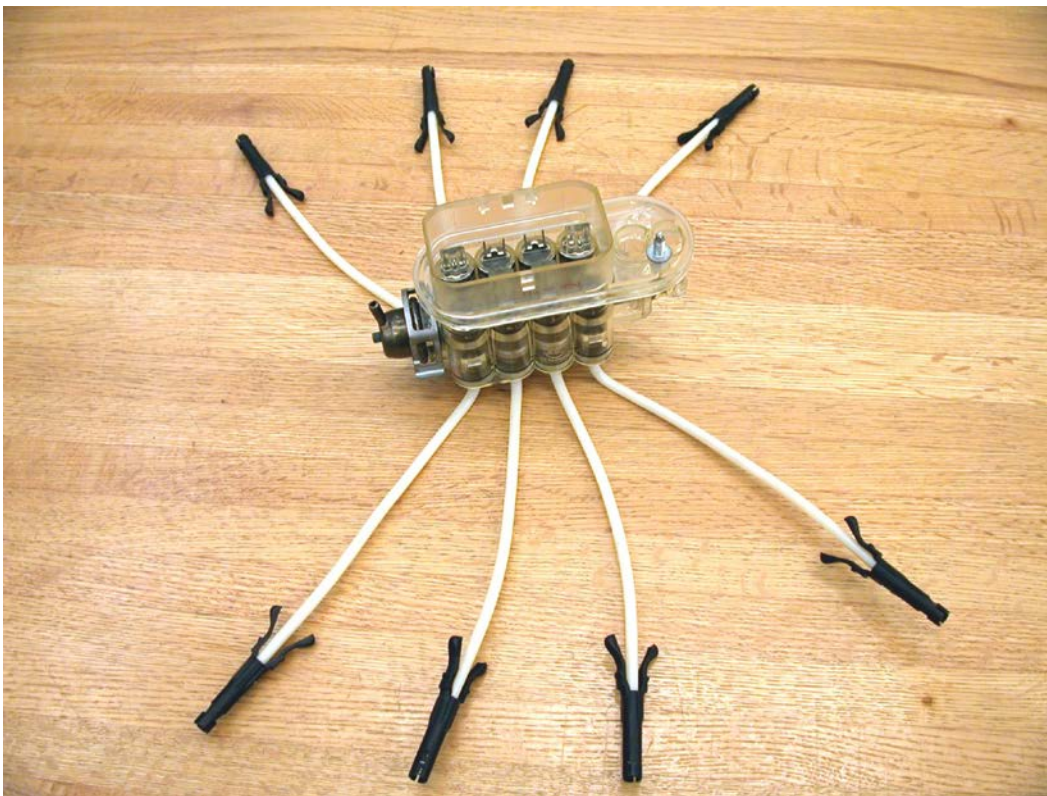
Halderman: The first step is to have an experienced service technician verify the fault by visual inspection by partially disassembling the intake manifold and looking for evidence of leaking fuel. After the problem has been confirmed, a replacement fuel pressure regulator (if available) or the entire fuel injection “spider” assembly may be necessary. The cost of the parts could exceed several hundred dollars plus labor, so it is very important that this fault be checked and confirmed.
