Wheels: We have an E-mail from a reader who has a 1996 Aurora with 72,000 miles on the odometer. The reader states that the accelerator sticks, especially the first time the engine is started. Do you have any ideas as to what can cause this?

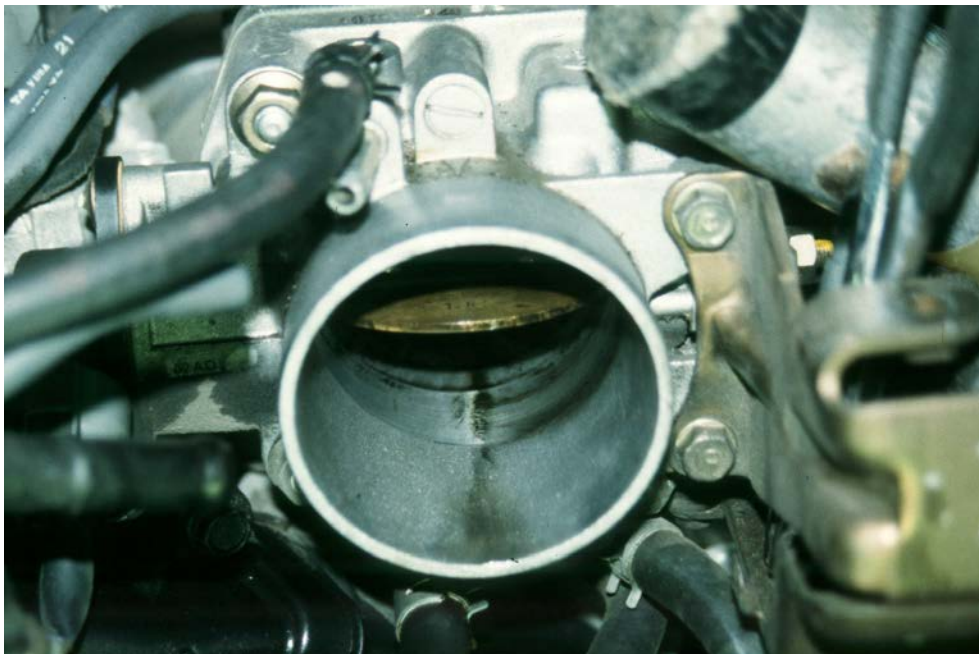
Halderman: The second possible cause is a kink in the throttle cable. This is a very dangerous possibility that should be checked because this damaged cable could cause the throttle to stick at other times and this could cause an accident if it occurs while you are driving. This is so important that General Motors Corp. has released a service bulletin stating that service technicians are to replace the throttle cable if the engine has been removed. This precaution is to prevent the possibility that the throttle cable could have been deformed or kinked during the engine replacement. Look for any signs of kinking of the cable especially if service work has been done to the vehicle such as resealing of the intake manifold. Service technicians often disconnect the throttle cable and linkage during an assembly and place it to the side of the engine compartment to make working on the engine easier.
