Wheels: Don of Springfield has a 1989 Pontiac Grand Am that seems to upshift and downshift between 45 and 50 MPH. Do you have any ideas?

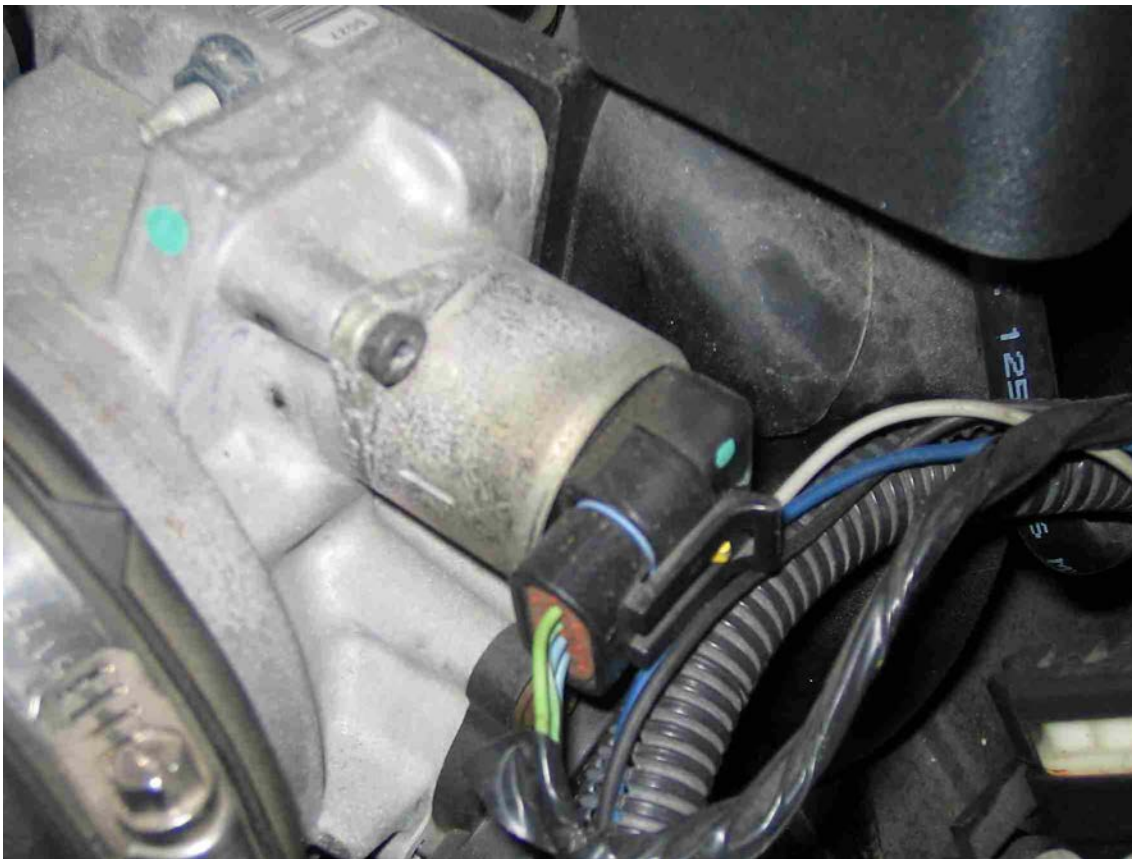
Halderman: I believe the “shift” you are feeling is the applying and releasing of the torque converter clutch (TCC) also called a lock-up torque converter. The TCC applies to reduce slippage that normally occurs inside a torque converter, which is part of an automatic transmission/transaxle. It is normal for the TCC to apply between 30 MPH and 45 MPH depending on engine load and throttle opening. For example, if the driver is accelerating, the torque converter clutch application is delayed. The problem could be caused by a fault or misadjusted throttle position (TP) sensor. Also a fault with the vehicle speed (VS) sensor could cause the TCC to engage and then disengage if the computer “thinks” that the vehicle speed is changing. A misadjusted brake switch could also cause your problem because the brake switch electrically shuts off electricity to the TCC when the brakes are applied. These types of faults will not set a diagnostic trouble code so an experienced technician should be consulted in the attempt to correct this concern.
