**Wheels:** A writer asks, “I would like information regarding a collapsed torque mount. The car is a 1995 Saturn. How serious is this problem? How does it affect the steering?”

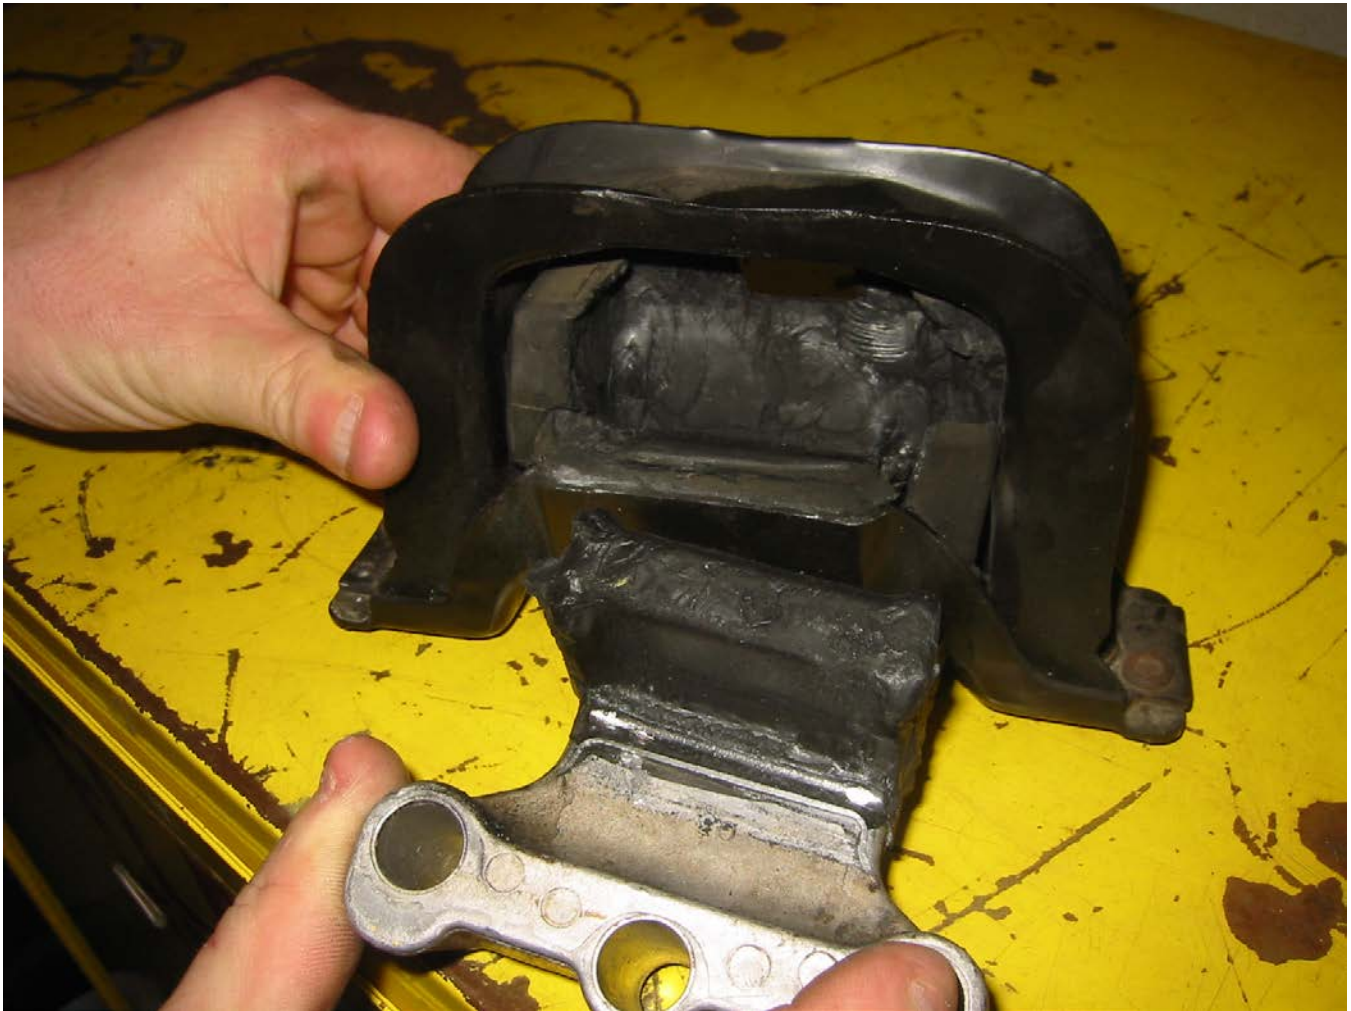
**Halderman:** The engine mount supports the engine and absorbs engine torque as it tries to rotate in the engine compartment as the vehicle is being driven. If this mount were to fail (collapse), the front drive axle shaft angle is affected, which changes the amount of torque delivered to the front wheels during rapid acceleration or when shifting gears. It is this unequal torque that causes the vehicle to move in one direction when accelerating. This condition is called torque steer and the most common cause is due to defective engine and/or transaxle mounts. While replacing the mount will not completely eliminate torque steer on a front-wheel-drive vehicle, it will restore it to the lowest possible amount.
