Wheels: Roy of Fairborn has a 1990 Oldsmobile Cutlass Ciera with 160,000 miles that has a stalling and engine idle speed problem. After more than \$500 worth of repairs, the stalling problem is fixed but now the engine speed doesn't decrease when slowing to a stop. What is your opinion?

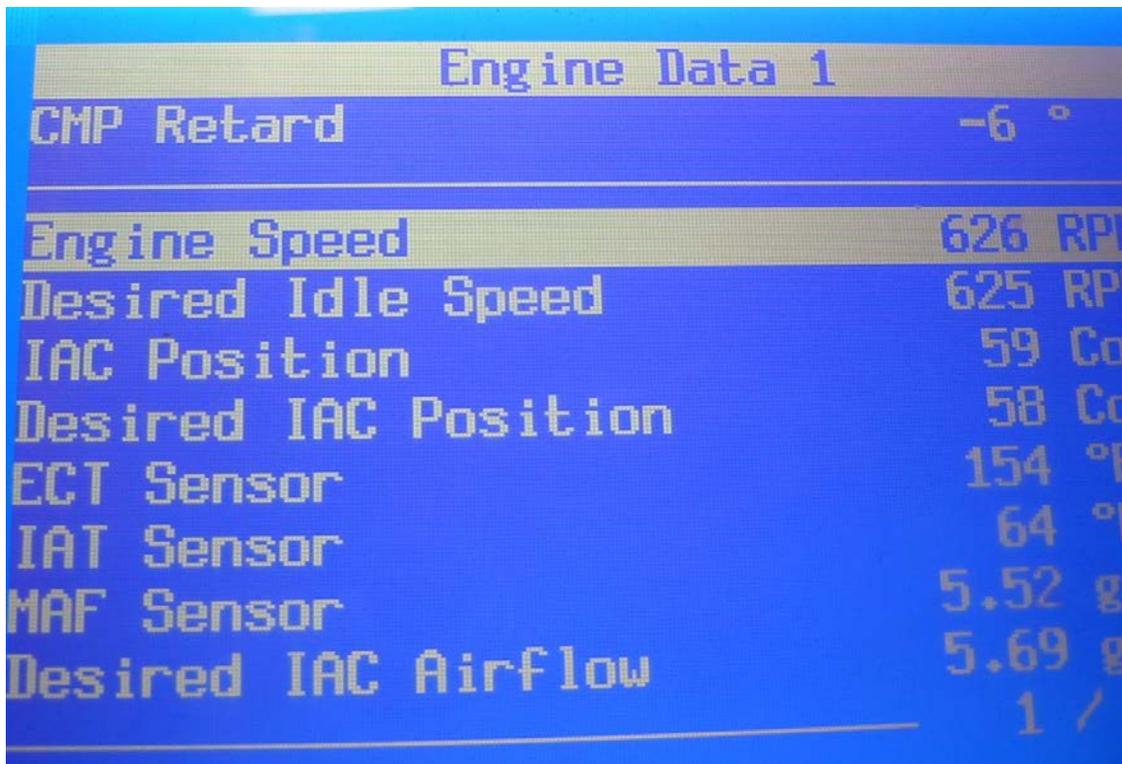
| Engine Data 1 | |

| Engine Data 1 | |
|---|---|
| CMP Retard | -6 ° |
| Engine Speed | 626 RPM |
| Desired Idle Speed | 625 RPM |
| IAC Position | 59 Co |
| Desired IAC Position | 58 Co |
| ECT Sensor | 154 °F |
| IAT Sensor | 64 °F |
| MAF Sensor | 5.52 g |
| Desired IAC Airflow | 5.69 g |

Halderman: The best way to diagnose this problem involves connecting a scan tool to the vehicle computer connector under the dash near the steering column. The service technician can then observe the commanded position of the IAC. It should be about 15 to 25 steps or counts at idle. If the idle speed is too high and the IAC counts are low, this indicates to me that the engine has a vacuum leak. The most likely cause of a vacuum leak is at the intake manifold gasket or a hole in one of the vacuum hoses.
