chapter **70**

# Used Vehicle and Pre-Delivery Inspections

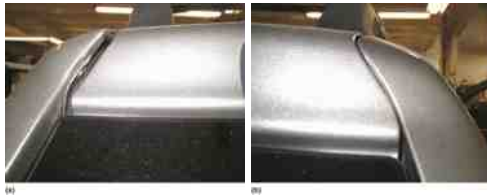
**FIGURE 70.3** (a) The left side of a lift gate on an SUV shows a wide gap. (b) The right side of the same lift gate on the passenger side shows a very small gap. This shows that this vehicle may have been in an accident and not properly repaired.
